MEDIC UPDATE

TECHNICAL SERVICE BULLETIN

| SUBJECT: | | No: TSB-07-13-007 | |
| ENGINE CONTROL MODULE REPROGRAMMING FOR THROTTLE HESITATION | | DATE: July, 2007 | |

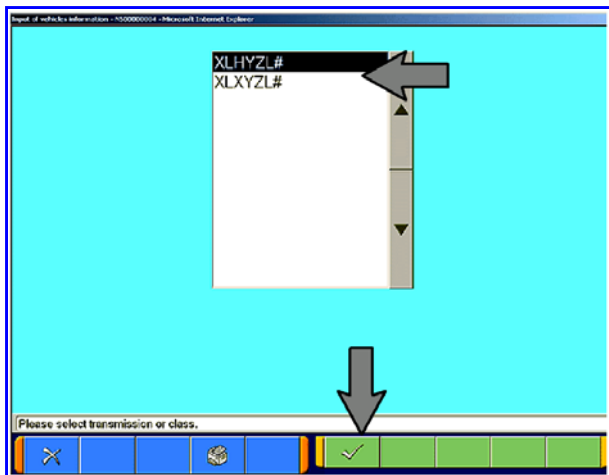
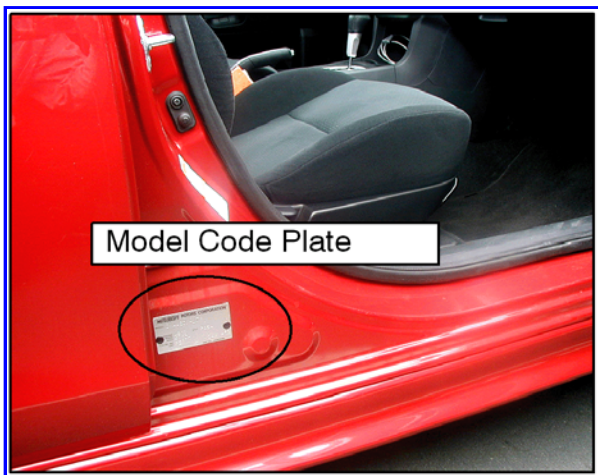
h. If it was not completed automatically, input the vehicle class. Click on the CLASS button, select the appropriate class from the menu (below left) and then click the check mark at the bottom of the page. Vehicle class can be found on the Vehicle Information Code Plate riveted to the base of the RH b-pillar (see photo below right). The class is part of the model code.

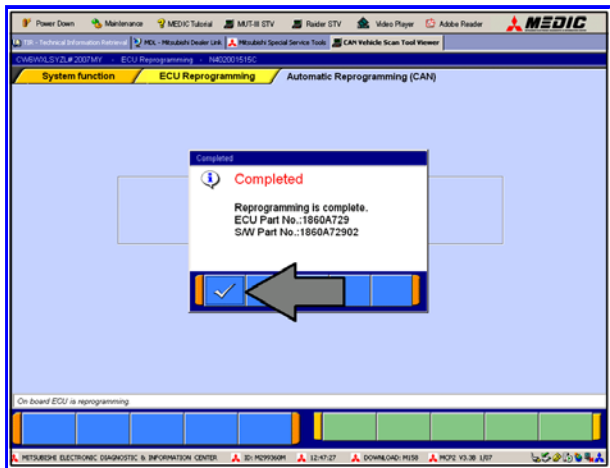
m. This message will display when the ECM reprogramming is successfully completed. Record the S/W (Software) Part No. and compare it to the "New Part No." in the table in attachment 1 at the end of this TSB.

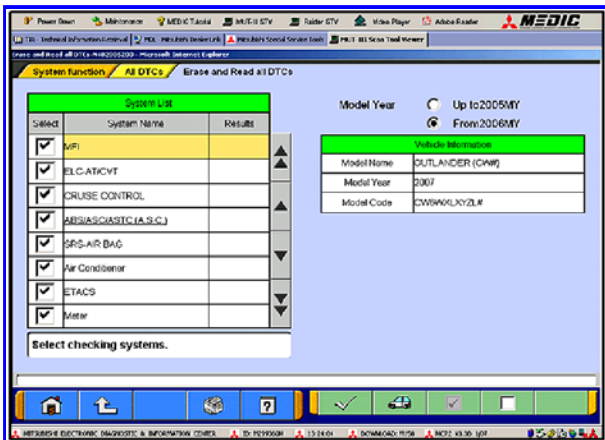
c. Inspect the list on the left side of the screen and ensure that the correct options **ONLY** are checked. DTCs will be set if the the options are incorrectly entered.

Note that the selctions for ABC/ASC/ASTC and for FAST/IMMOB/KEYLESS are underlined. Certain models require you to select the correct optional equipment. Clcik on the underlined term and if given a selection, check the correct option from the list.

- If DTCs remain, diagnose and repair the condition as per the Service Manual. If no additional DTCs are listed, click the check mark to clear the window and then click the Home icon in the lower left of the screen to return to the main menu.

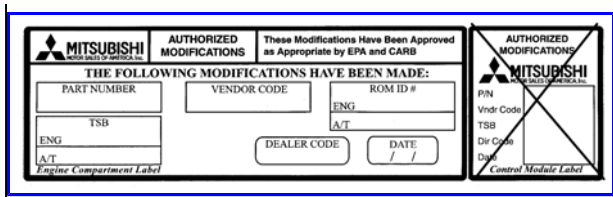
The Control Unit Label is NOT used for this reflash. It should be discarded.

- Using a ball-point pen, enter the appropriate Engine Control Module (ECM) part number, vendor number, ROM ID#, this technical service bulletin number (**TSB-07-13-007**), your dealer code, and the current date on the Engine Compartment / Control Module Label (p/n MSSF-024G-00). The label is available from your facing PDC.

- Carefully remove all dirt and oil from a vacant area near the VECI label on the underside of the hood, and affix the *Engine Compartment Label* (LH side, above) to that area.
