# Technical Service Bulletin

<b>SUBJECT:</b> <b>DTCs P0657, P1590, U0101, P0201 – P0206 &amp; POSSIBLE NO START</b>			<b>No:</b> <b>TSB-07-13-010</b>
			<b>DATE:</b> <b>December, 2007</b>
			<b>MODEL:</b> <b>See Below</b>
<b>CIRCULATE TO:</b>	<input type="checkbox"/> GENERAL MANAGER	<input checked="" type="checkbox"/> PARTS MANAGER	<input checked="" type="checkbox"/> TECHNICIAN
<input checked="" type="checkbox"/> SERVICE ADVISOR	<input checked="" type="checkbox"/> SERVICE MANAGER	<input checked="" type="checkbox"/> WARRANTY PROCESSOR	<input type="checkbox"/> SALES MANAGER

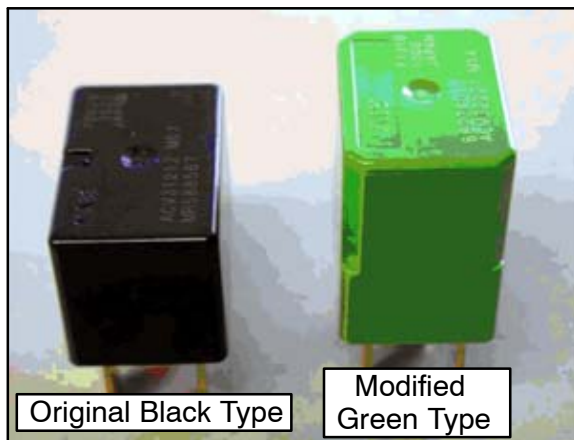
1. Identify which type of relay is fitted in the relay box. If the vehicle is fitted with the "Original Black Type," continue with the following steps. If it is fitted with the "Modified Green Type," diagnose the condition as per the service manual
2. Using the MUT-III, read DTCs and record Freeze Frame Data. Note if the data shows the intake air temperature at approximately -5° F (-20°C) or colder.
3. Erase any DTCs and start the vehicle.
4. Check for provisional DTCs.
5. If no DTCs are reset, perform the following steps to replace the relays.

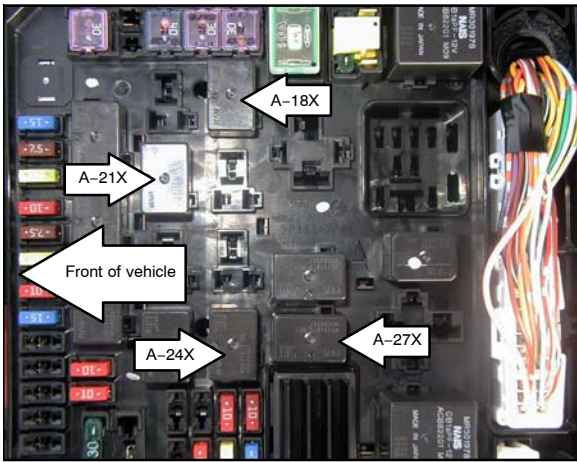
**NOTE: ONLY INSTALL A NEW RELAY IN LOCATIONS INDICATED IN THE PHOTO.**

6. Replace the following relays with the updated type as described in the Parts Information section of this bulletin.
- A-18X      A/T Control Relay
  - A-21X      Throttle Valve Control Servo Relay
  - A-24X      Injector Relay
  - A-27X      Starter Relay
