# MEDIC UPDATE

## TECHNICAL SERVICE BULLETIN

SUBJECT:		No: <b>TSB-07-23-006</b>	
<b>TCM REPROGRAMMING FOR DTC P0712, P0713 &amp; "SERVICE REQUIRED" DISPLAYED WITH NO MIL</b>		DATE: <b>July, 2007</b>	
		MODEL: <b>2007 Outlander</b>	
CIRCULATE TO:	<input type="checkbox"/> GENERAL MANAGER	<input checked="" type="checkbox"/> PARTS MANAGER	<input checked="" type="checkbox"/> TECHNICIAN
<input checked="" type="checkbox"/> SERVICE ADVISOR	<input checked="" type="checkbox"/> SERVICE MANAGER	<input checked="" type="checkbox"/> WARRANTY PROCESSOR	<input type="checkbox"/> SALES MANAGER

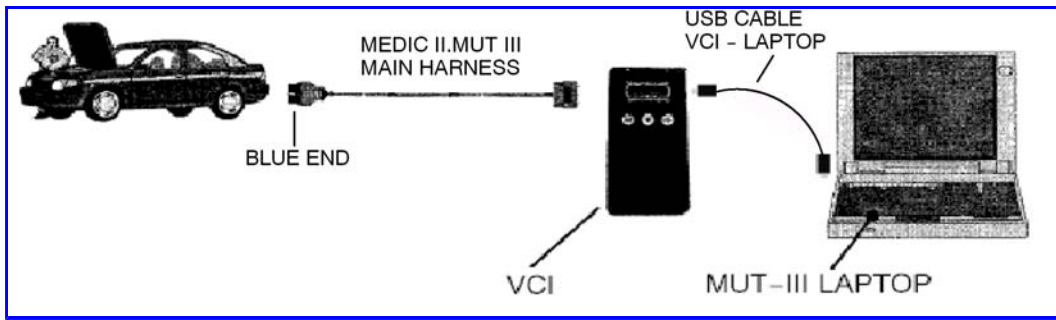
1. Connect the USB cable to the VCI.
2. When the laptop displays the MUT-III main screen, connect the USB cable to the laptop.
3. Connect the MUT-III main harness with the blue DLC connection to the VCI.
4. Connect the blue connector of the MUT-III main harness to the vehicle's data link connector.
5. Turn the VCI power switch ON. Verify that the indicator lamp in the upper right corner of the screen is green.

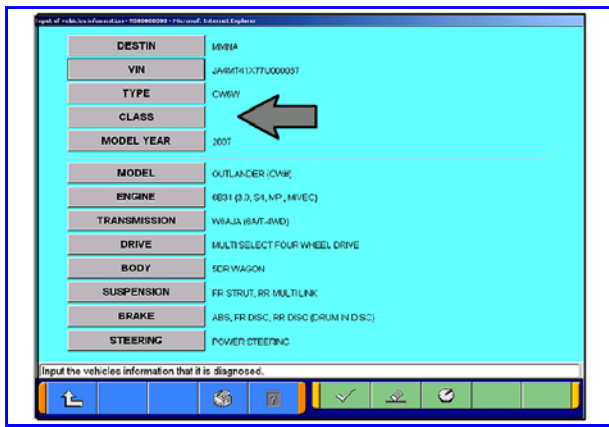
h. If it was not completed automatically, input the vehicle class. Click on the CLASS button, select the appropriate class from the menu and then click the check mark at the bottom of the page. Vehicle class can be found on the Vehicle Information Code Plate

riveted to the base of the RH b-pillar (see photo below). The class is part of the model code.
